FAILURE ANALYSIS OF HAUL TRUCK FINAL DRIVE GEARS

Rachman Setiawan, Budi Hartono Setiamarga, Bambang Widjanto

Fakultas Teknik Mesin & Dirgantara ITB,
Gd. Labtek II, Jl. Ganesha 10, Bandung 40132

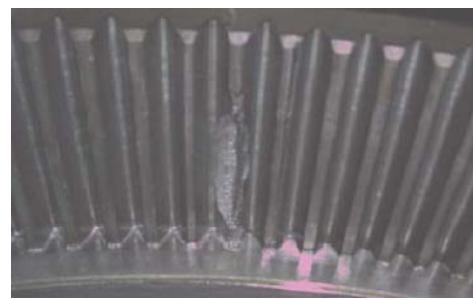
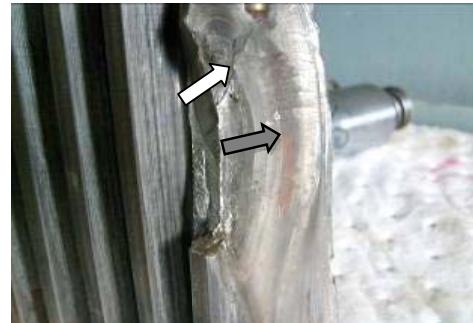
Figure 3a is a picture taken by KPC engineers showing the failure of first stage ring gear before disassembled. It shows that one of the teeth of the ring gear breaks at its root, from one face to the other. It is estimated that this was the first failure. After disassembled (Figure 3b), it can be seen that: the breakage extends to the outer face of the ring gear; smooth beachmark is found towards the outer face as well as to the other face of the gear; Crack initiation is estimated as shown by the white arrow, by the location of the center of beachmark and the direction of the chevrons (grey arrow). The crack shape identification requires microscopic analysis, leading to the cause of crack, hence the failure.

Figure 3 Visual examination, from top: First ring gear (attached), First ring gear (detached)

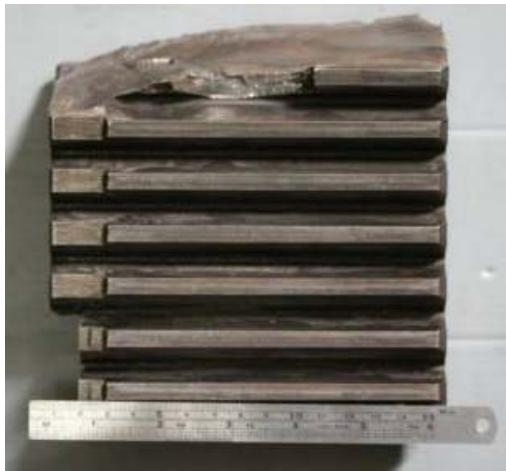
Figure 5 Original specimen for material test.

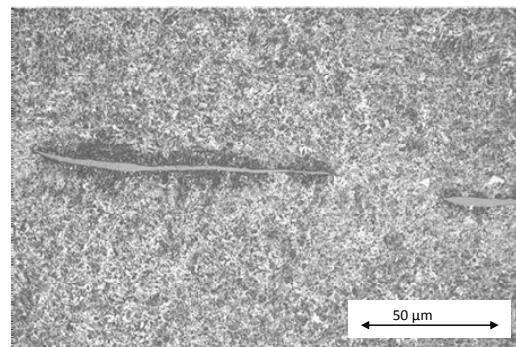
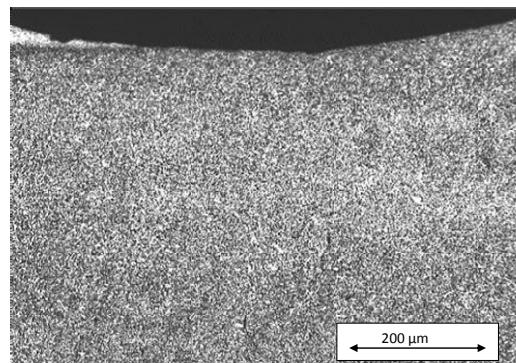
From the optical metallography, the microstructure of each specimen are found. There are some small amount of inclusions present. Unfortunately, some inclusions happen to be close to each other as can be seen in Figure 7. The presence of inclusions at the size of up to $150 \mu\text{m}$, which is close to one another will tend

to increase the stress intensity factor, which is not good for the integrity of the gear.

Figure 7 Examples of microstructure of the gear showing the presence and absence of inclusion.

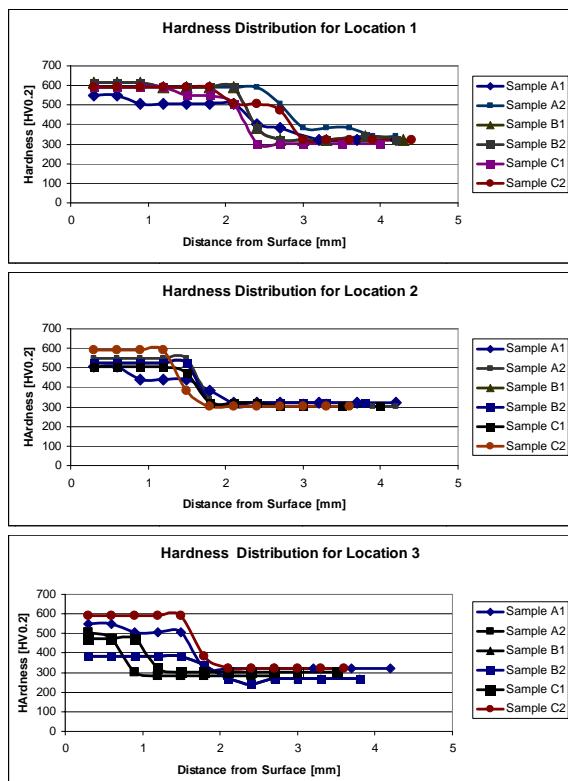
The micro hardness measurement is carried out on three locations on each gear tooth sample, i.e. face area (location 1), root area (location 2) and tip area (location 3). The measurement results is presented in Figure 8. In general, the test shows that hardness of the face area has higher hardness compares to the root (location 2) and tip (location 3) areas. This is appropriate because the face area will endure friction force so that it will need a better wearability. On the other hand, the root area must have good toughness property because this area endures the highest stress. Therefore it would not be appropriate for the root area to have higher level of hardness. However, it can be seen from Figure 8, that the root hardness can reach almost 600 HV0.2 , close to the surface area. The higher the hardness of the material, the lower will be its toughness. Therefore, it is undesirable for the tooth-root area to have higher hardness. At the root area, the combination of higher hardness due to inconsistent heat treatment that will result in lower fracture toughness and the presence of the unfavourable orientation and distribution of inclusions will create a damaging effect.

Figure 8 Micro-hardness test results for 6 specimens, on 3 locations: face, root and tip.

Finally, the material test includes the Optical Emission Spectroscopy (OES), that gives information on the chemical composition. As presented in Table 2, and by comparing with the closest material standard, it is found that the carbon content is slightly above the standard of AISI 4340 [7]. The higher carbon content will make the hardenability of the steel to be higher. It means that the hardening process will be able to create a deeper hard area. The effect of variation of the carbon percentage on the hardenability, hence the hardness of the material upon the same hardening process, can be seen in Figure 8. At the tooth-root, the combination of

higher hardness due to inconsistent heat treatment that will result in lower fracture toughness and the presence of the unfavourable orientation and distribution of inclusions will create a damaging effect.

- Improvement on the heat treatment technique and process, including higher control of carbon percentage and hardening profile.
- Early detection on tooth breakage can be carried out by observing the vibration of the final drive, i.e. by running the wheels with rear wheels jacked-up on constant speed. This action plan can be applied during the existing maintenance/regular maintenance.

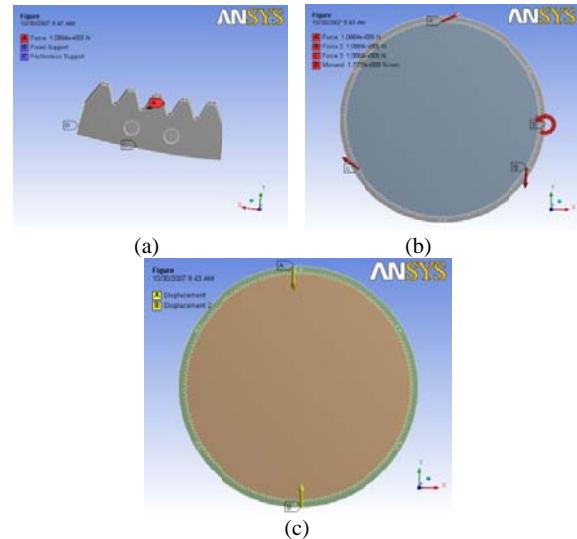
Figure 9 FE Model: a) segmented gear, b) whole gear, c) whole gear model with lateral load

From the finite element analysis, the principal stress is selected to be monitored, so that can be compared with the AGMA solution. The result for loading case 1 (tooth load only) can be compared between the two FE model, i.e. segmented and full ring gear in. The segmented model (Figure 9) gives the maximum principal stress of 358 MPa, whilst the full model gives 302 MPa for loading case 1, after a factor of 1.67 is applied due to load distribution. Comparison with the result of AGMA prediction is given in Table 4.
