Failure Analysis of Fixed Drive Link of Flap Track Fairing (Canoe #8) of a Wide Body Aircraft

The failure analysis has been performed on fractured fixed drive link of flap track fairing (Canoe) #8 in drive system secondary door of a wide body aircraft. The fixed drive link is made from Aluminum Alloy 7075 per CMM 27-51-31 and OES test result. To support the analysis, laboratory practices including visual fractography, Optical Emission Spectrometry (OES), stereo microscopy, Scanning Electron Microscopy (SEM), Energy Dispersive Spectrometry (EDS), tensile test, and hardness test were conducted. The evidence shows that the fracture is initiated from area of the circle radius of fixed drive link. Beachmark is clearly observed at fractured surface as indication of fatigue failure. Final fast fracture of the fixed drive link impacted on spontaneous crack in the downstream of the drive system and also resulted in deformed forward door link. The tensile strength and hardness of the component are below the standard of AA 7075-T6 alloy. Quantitative stereo metallography shows higher percentage fraction of undesired constituent particle on the area adjacent to crack origin indicating that th

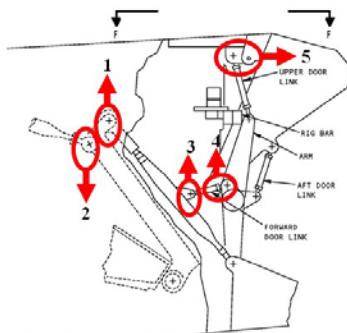
Fig.4 Connection between failed parts and position of fractures [2] [3]

There are total four failed parts in the secondary door drive system. The connection between each parts and location of fractures are illustrated in Fig.4.

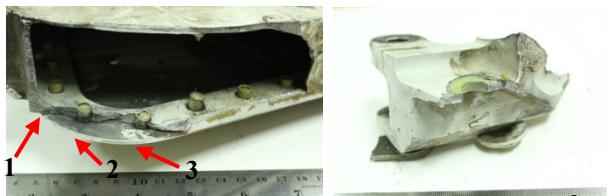
Fig.5 Fracture surface on component #1 (a) and component #2 (b)

Fracture in Component #1 can be seen in Fig.5a. It shows multiple crack initiation. A dirty surface condition indicates that the crack has been there long time since dirt or grease can infiltrate into the narrow gap. A beachmark feature also can be found in the corner area (shown by the red arrow 1 in Fig.5a. The two blind fasteners also can be suspected as crack initiation based on previous cases in the same components [12].

Fracture surface shown in Fig.5b, Fig.6 and Fig.7c show rapid fracture. The macro-photography shows no feature of fatigue failure on fracture surface. The deformed Forward Door Link (Fig.7a) shows that the component sustained overload force. The overload encountered by Forward Door Link can arise from damage of other components previously. There are also no special features of fatigue failure, obtained from its fracture surface [7]. From this step we can determine that failed component #2, #3, #4, and #5 of Fig.4 are not the origin of failure in the drive system. Therefore, the next investigation was focused on failed Fixed Drive Link. Since there were three possibilities of crack initiation area, the further macro-photograph should be taken in those areas. The results can be seen in the Fig.8.

1. Detail visually inspect drive links for loose cover plate fasteners and/or cracks in the link body itself every "C" check per MPD 57-610-00 and MPD 4-57-041. If cracks or loose fasteners are found, remove the link and replace it.
2. Ensure the flap moveable fairings are rigged properly [11]. The moveable fairing should not be pulled too tightly or unevenly against the lower surface of the flaps which may result in a fully compressed bulb seal condition. If the flap fairing is pulled up unevenly, the link can be asymmetrically loaded causing increased loading to one side of the link. The reference AMM [11] for the outboard flaps have been revised to provide updated rigging instructions for the fairing itself along with the primary and secondary doors on the #1 & #8 fairings.

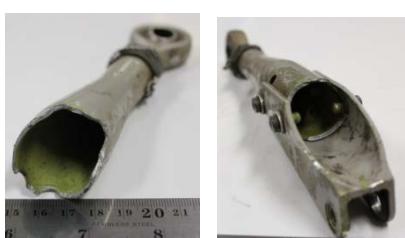
Fig.6 Fracture surface of component #3 from Fig.4. The Adjustable rod components were broken and split into two parts

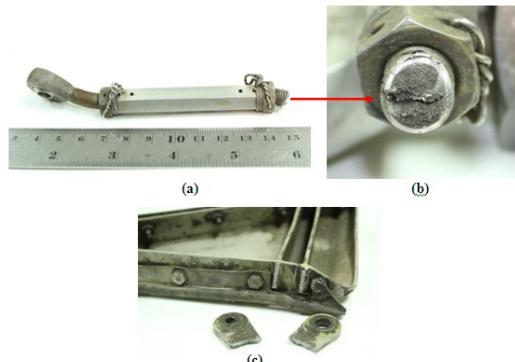
Fig.7 Failed component #4 in Fig.4. The deformed component (a), its fracture surface (b), and component #5 from Fig.4

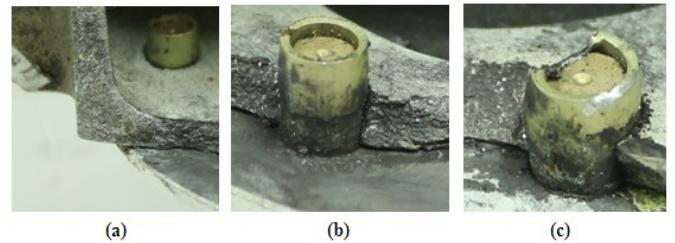
Fig.8 Crack initiation suspect areas from (Fig.5) arrow 1 (a), arrow 2 (b), and arrow 3 (c)

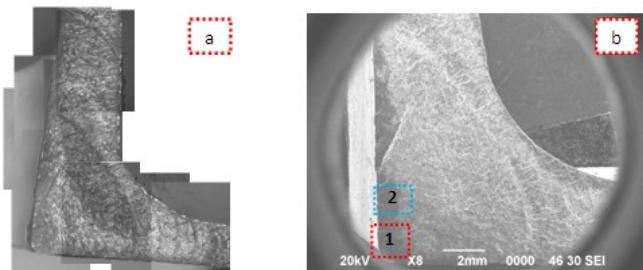
Fig.9 Fractograph of part (Fig.8a) using stereo microscope (a), and low magnification SEM (b).

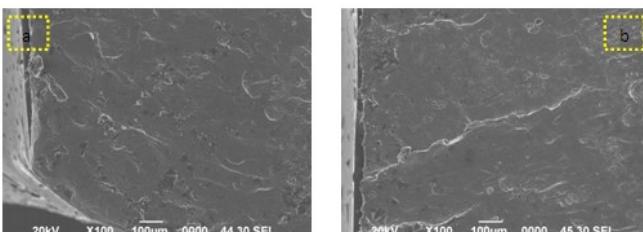
The observation on fracture surface using higher magnification SEM was performed to determine the crack initiation and crack propagation area. In the crack initiation area shown in Fig.10, there is no evidence of mechanical damage, local deformation, or corrosion. Fig.11a shows difference feature of fracture surface between crack initiation and propagation.

Fig.10 SEM images of area 1 (a), area 2 (b) from Fig.9b

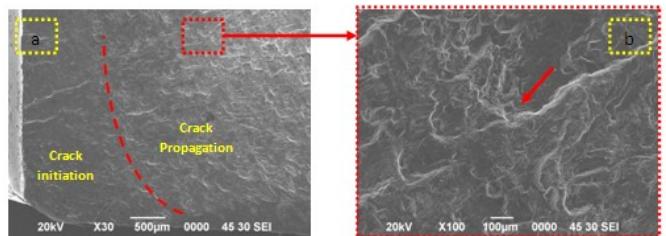
On the crack propagation area, as shown in Fig.11b, the morphology of fracture surface shows many elongated dimples with open-end rim. The striation can

Fig.11 Fracture surface difference between crack initiation area and crack propagation area (a), showing dimple morphology (b)

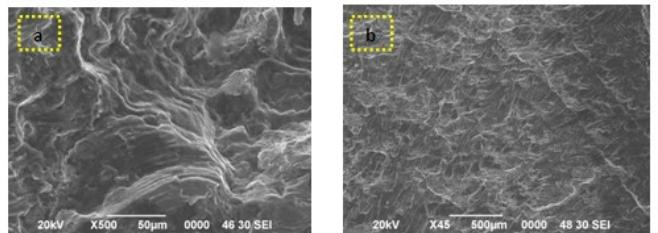
Fig.12 Striation on crack propagation, magnified from arrow in Fig.11b. (a) Fracture surface near the final failure area showing combination of dimple and cleavage (b)

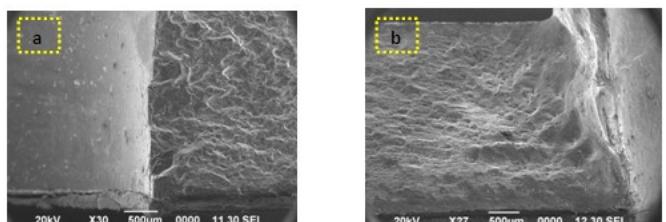
The fracture surface of other possibility areas of crack initiation shown in Fig.13 does not reveal the features as crack initiation areas. The fast/ final fracture areas are combination of dimple and cleavage which show a random direction.

Fig.13 SEM image of fracture area of part in Fig.8b (a), Fig.8c (b)

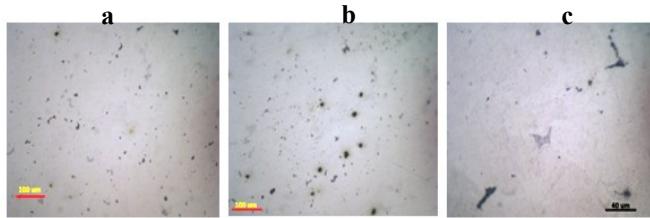
Fig.14 Un-etched microstructure from area far from initial fracture (a & b), area adjacent to initial fracture (c), under stereomicroscope

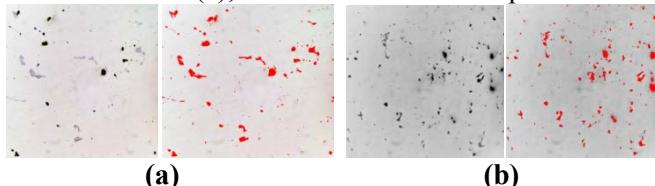
aluminum matrix under stereo micrograph quantitative metallography (Fig.15), there are 3.06% (area #1); 3.17% (area #2) and the result under SEM quantitative fractography (Fig.16), there are; 0.76 % (area #a), 0.58 % (area #b), and 0.39 % (area #c), respectively.

Fig.15 Un-etched microstructure on area adjacent to initial fracture (a&b) showing fraction of insoluble phase under Rax vision analysis

Based on data of percentage of insoluble phases shown in Fig.15 and Fig.16, the fraction of insoluble phases in the failed component under stereo quantitative metallography and SEM quantitative metallography, there are 3.06% (area #1) and 3.17% (area #2). This value is higher than the industrial homogenized Aluminum [15]. Fig.15 confirms that the component was not homogenized properly. It could be the homogenizing time was too low or holding time was too short. Whereas, the area far from crack initiation contains insoluble phase lower than that of the area close to crack initiation, as shown in Fig.16, there is 0.76 % (area #a), 0.58 % (area #b), and 0.39 % (area #c), respectively.

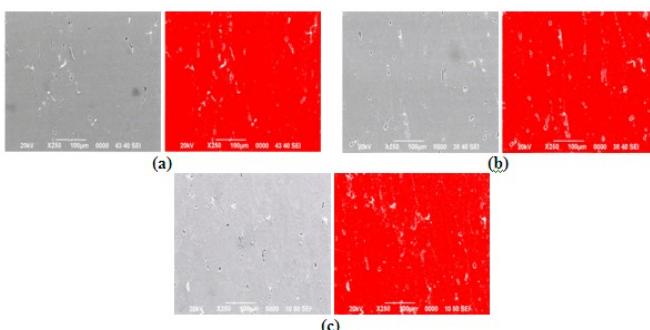
Fig.16 Un-etched SEM microstructure on area far from initial fracture under Rax vision analysis

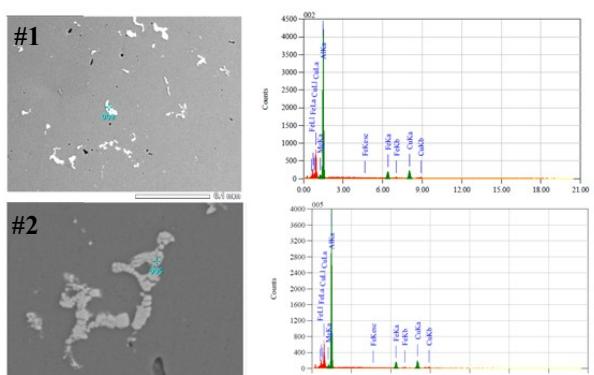
Fig.17 shows microstructure examination under EDS illustrating the composition of the element in insoluble phases and constituents in aluminum matrix. Most of the elements are in grain boundary with high level of element Cu or Fe.

Fig.17 EDS result for insoluble phases in the area far from the crack initiation showing similar composition of constituents

EDS result in Fig.17 indicates that the constituents are $\text{Al}_7\text{Cu}_2\text{Fe}$ that is common constituents in 7X75 wrought alloys. The SEM and EDS analysis indicates in addition to excess fraction of constituents in the area far from fracture, the structure and constituents are normal. The EDS result in Fig.18 shows the particle with Cu as the main element (63% mass fraction). This particle is uncommon for its composition and size. The size of this particle is more than 50 μm as the maximum size of normal constituents in Aluminum alloy. Since the coarse particle with have size more than 1 μm will deteriorate the fatigue performance [15], this Cu-rich particle has the possibility to reduce the fatigue strength in local surrounding area. This Cu-rich particle did not found in the area far from crack initiation and test result indicated that this particle has no effect on hardness of material.

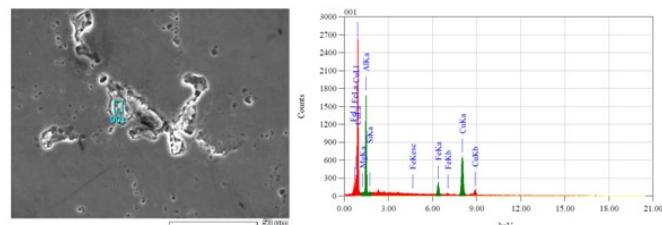
The EDS result for area adjacent to crack initiation shows the constituent with high percentage of Cu. Elements composition of this constituent is difference with the composition of constituent in the area far from crack initiation.

Fig.18 EDS result for insoluble phases in the area far from the crack initiation shows similar composition of constituents

1. The study of Cu-rich particle shown in Fig.7 should be done including the spread and fraction of its particle and its effect to the change of mechanical properties.
2. The stress analysis using FEM is also required to determine the area that most prone to fail.

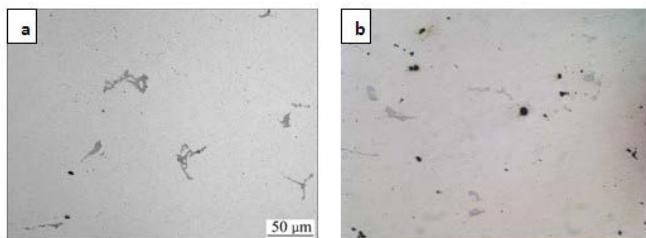
Homogenizing or Ingot Pre-Heating is a process to improve hot workability alloy by reducing the composition segregation in as-cast ingot. The industrial homogenization temperature for 7075 is 470°C and hold for 48 hours [13]. The microstructure of homogenized Aluminum alloy can be seen in Fig.21a. Due to reduction of segregation, the alloying elements such as Mg, Zn, Cu, and Fe that formed eutectic structure in as-cast ingot can dissolve into Aluminum matrix when homogenization occurs. The enhancement of alloying content especially Mg, Zn, and Cu can increase the strength of materials due to the enhancement of strengthening precipitates formed during solution heat treatment and artificial aging. The microstructure of failed Fixed Drive Link on Fig.21b shows that the material contains many second-phase constituents. The amount of second-phase particles in the failed component is higher than the

microstructure of industrial homogenized Aluminum as shown in Fig.21a.

Fig.21 Un-etched microstructure of (a) Industrial homogenized Al-Zn-Mg-Cu alloy [14], (b) Failed Fixed Drive Link component
