FAILURE ANALYSIS OF HAUL TRUCK FINAL DRIVE GEARS

Rachman Setiawan, Budi Hartono Setiamarga, Bambang Widjanto

Fakultas Teknik Mesin & Dirgantara ITB,
Gd. Labtek II, Jl. Ganesha 10, Bandung 40132

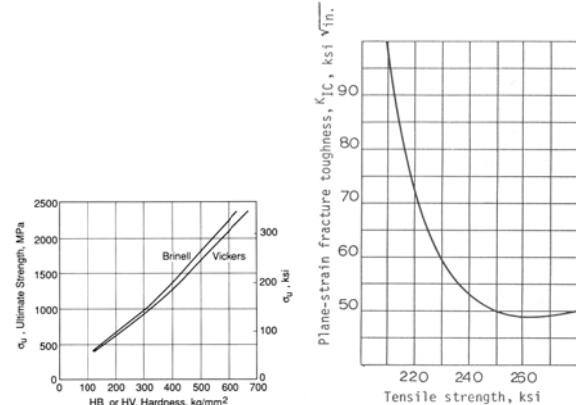
Figure 10 Material property relationship, from left: Hardness-UTS [8], and UTS and fracture toughness [9]

According to spectrometry test and after confirmed with the manufacturer, the gear material is known to be AISI4340. From micro-hardness tests on various locations, it is found that the hardness of the tooth is approximately 600 HV (Vickers) on the surface and 324 HV at the base material. The ultimate strength can be estimated, for surface and base material, respectively, 2070 MPa and 1000 MPa, according to Figure 10a [8].

Furthermore, the fracture toughness, K_{IC} , for the gear can be found from the relationship as in Figure 10b, i.e. $40 \text{ MPa m}^{1/2}$ (at the surface), and $180 \text{ MPa m}^{1/2}$ (base material).
