Failure Analysis of Fixed Drive Link of Flap Track Fairing (Canoe #8) of a Wide Body Aircraft

The failure analysis has been performed on fractured fixed drive link of flap track fairing (Canoe) #8 in drive system secondary door of a wide body aircraft. The fixed drive link is made from Aluminum Alloy 7075 per CMM 27-51-31 and OES test result. To support the analysis, laboratory practices including visual fractography, Optical Emission Spectrometry (OES), stereo microscopy, Scanning Electron Microscopy (SEM), Energy Dispersive Spectrometry (EDS), tensile test, and hardness test were conducted. The evidence shows that the fracture is initiated from area of the circle radius of fixed drive link. Beachmark is clearly observed at fractured surface as indication of fatigue failure. Final fast fracture of the fixed drive link impacted on spontaneous crack in the downstream of the drive system and also resulted in deformed forward door link. The tensile strength and hardness of the component are below the standard of AA 7075-T6 alloy. Quantitative stereo metallography shows higher percentage fraction of undesired constituent particle on the area adjacent to crack origin indicating that th

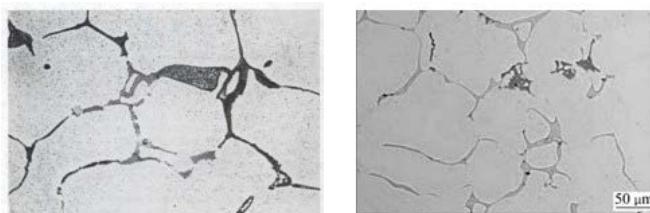
Fig.20 Microstructure of as-cast Al-Mg-Zn Cu alloy ingots. A darker area shows a grain boundary with higher content of alloying elements [11, 14].

As-cast aluminum ingot has segregated composition and structure with dendritic α phase and lamellar eutectic formed between dendrite [11]. Although the composition of alloying elements is in hypoeutectic, the eutectic structure can be formed. The forming of eutectic structure is possible due to non-equilibrium solidifications that were explained by Porter and Easterling [14]. The microstructure of as-cast Al-Mg-Zn-Cu alloy is shown in Fig.20.

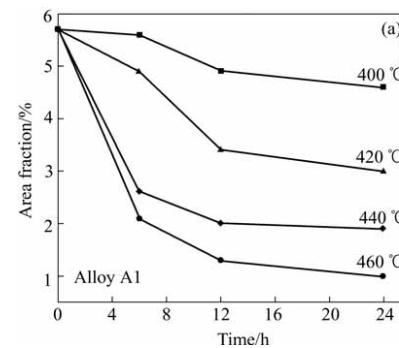
Fig.22 Evolution of area fraction of phases other than α dendrites during heat treatments [15]

The percentage of second-phase constituents in Aluminum alloy should be decreased during homogenization. Homogenization can also increase hardness, yield strength, and tensile strength without much change in elongation [15]. Fan Xi-Gang and Jiang Da-Min [15] have observed the fraction of phases other than α dendrite in Al-Zn-Mg-Cu alloys. The fraction of second-phase particle in Al-6.2%Zn-1.7%Cu-2.3%Mg decreases with the function of time and temperature. Fig.21 shows the fraction after various homogenizing time and temperature.

Based on data of percentage of insoluble phases shown in Fig.15 and Fig.16, the fraction of insoluble phases in the failed component under stereo quantitative metallography and SEM quantitative metallography, there are 3.06% (area #1) and 3.17% (area #2). This value is higher than the industrial homogenized Aluminum [15]. Fig.15 confirms that the component was not homogenized properly. It could be the homogenizing time was too low or holding time was too short. Whereas, the area far from crack initiation contains insoluble phase lower than that of the area close to crack initiation, as shown in Fig.16, there is 0.76 % (area #a), 0.58 % (area #b), and 0.39 % (area #c), respectively.
