THE EFFECT OF FIBER VOLUME FRACTION ON THE IMPACT PROPERTIES OF COIR FIBER-REINFORCED EPOXY COMPOSITES

Sudarisman^{1,a}, Berli Paripurna Kamil¹, and Dwi Atmaja Luhur Sayekti²

¹Mechanical Engineering Department, Universitas Muhammadiyah Yogyakarta

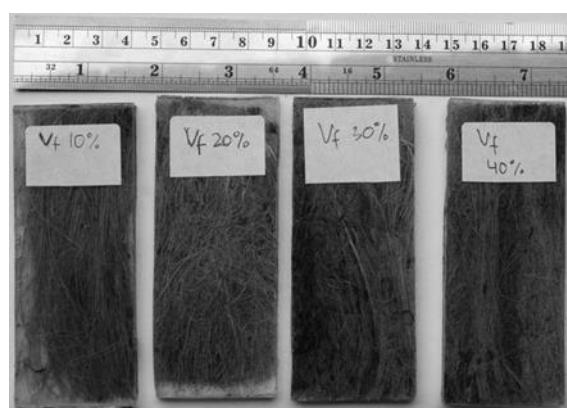
Figure 2. Composite plate panels after being cut into ~100 mm × 40 mm, and further would be cut into three specimens each

Specimens were cut from composite plate panels, Fig.2, produced using press-mold technique, using a diamond-tipped circular blade rotating at ~10,000 rpm. There are two cavities in the mold, such that two plate panels of different fiber content would be produced at each molding process. The dimension of the cavity is ~140×100×4 (mm^3). Thus, each plate panel can be cut into nine specimens. The two specimens cut from outer part of the panel were not used due to their high possible inhomogeneity that may produce inconsistent data. Prior to being cut off for edge inconsistency and further into specimens, the plate panels were post-cured at 50 °C for 2 hours. Specimen preparation and testing were carried out according to the ASTM D5941 standard [15], at the Laboratorium Material Teknik, Jurusan Teknik Mesin dan Industri, Universitas GadjahMada, Yogyakarta. The specimens are

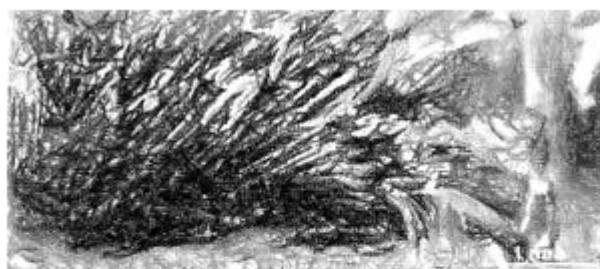
Figure 6. Cross sectional area of a broken specimen of $V_f = 0\%$ showing multiple fracture with irregular pattern.

It can be observed in Fig 6 that pure epoxy specimen experienced multiple fracture with irregular pattern. There is no deformation can be noticed. It suggests that this specimen is considerably brittle. This characteristic agree with that of cured epoxy for being commonly more brittle than coir fibers, resulting in lower absorbing capacity and impact toughness.

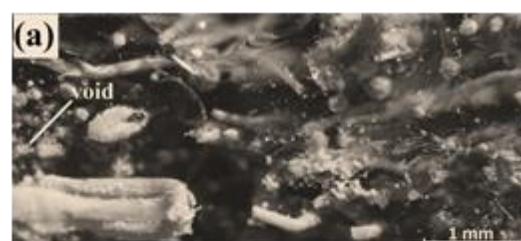
Figure 8. $V_f = 20\%$: (a) cross section shows some void on the right-hand side, (b) and (c) width and thickness views, respectively, both show some fiber pull-out.

Fig 8 shows photographs representative of broken specimens of $V_f = 20\%$. Fig 8(a) shows wide variation of fiber diameter. Fibers on the fracture surfaces exhibit clean surfaces indicating that fiber-matrix interface bonding is relatively weak, or may be of mechanical locking instead of diffusion or chemical bonding. Similar to those observed in Figs 7(b) and (c), Figs 8(b) and 8(c) also exhibited broken fiber being initiated with debonding followed by fiber pull-out. Uneven fiber distribution, where fiber-rich region are found in the middle of the specimen, can also be noticed in Fig 8(c). Figs 8(a), (b) and (c) also consistently demonstrate that debonding followed by fiber pull-out and fiber breakage dominates the failure mode. It can also be noticed that in comparison with Fig 7(a), Fig 8(a) demonstrates less longitudinally oriented fiber arrangement. Such condition may be responsible for the amount of energy being absorbed and impact toughness of $V_f = 20\%$ specimens being lower than those of $V_f = 10\%$ specimens.

Fig 9 shows photographs of representative broken specimen of $V_f \sim 30\%$. In comparison with Figs 7 and Fig 8, Fig 9 exhibited more densely packed fiber as expected. Whilst Fig 7(a) indicates more longitudinally oriented fibers and Fig 8(a) shows less longitudinally oriented fibers, Fig 9(a) exhibited more randomly oriented fibers. Similar to those observed in Figs 7(b), 7(c), 8(b) and 8(c), a considerable amount of fibers experienced

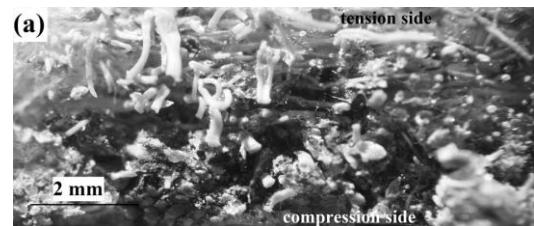
Figure 9. $V_f = 30\%$: (a) cross section shows some void on the right-hand side, (b) and (c) width and thickness views, respectively, both show some fiber pull-out.

Fiber pull-out can be observed in Figs 9(b) and 9(c). As has been observed for $V_f = 10\%$ and 20% specimens, most of fibers of larger diameter underwent fiber pull-out, while those of smaller diameters underwent fiber breakage can be noticed in Figs 9(b) and (c). It confirms that larger fibers possessing lower tensile load carrying capacity of fiber in comparison with shear load carrying capacity of fiber-matrix interface. In addition, Figs 9(b) and (c) also exhibited relatively randomly distributed fibers.

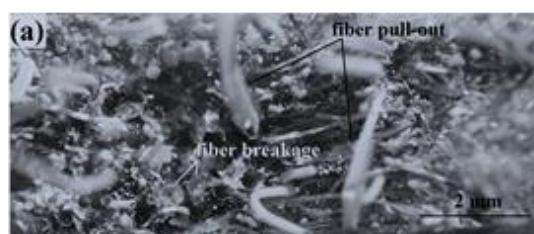
Figure 10. $V_f = 40\%$: (a) cross section shows some void on the right-hand side, (b) and (c) width and thickness views, respectively, both show some fiber pull-out.

Photographs of representative broken specimen of $V_f = 40\%$ have presented in Fig 10. Fig 10(a) shows that fiber diameter varies from ~ 0.1 mm to ~ 0.5 mm, and randomly oriented fibers. Fibers lying on the fracture surface show clean surfaces indicating that debonding has occurred. Such clean fiber surface can also be noticed in Figs 10(b) and (c). Similar to previous figures, larger fibers experiencing fiber pull-out and smaller fibers experiencing fiber breakage can clearly be noticed. Apart from those of $V_f = 10\%$, specimens for various fiber content failed in single surface fracture. Figs 10(b) and (c) exhibits clean fiber surfaces of those underwent pull-out. Orderly observing Figs 7 to 10, increase of fiber density as expected can be noticed.
